NEREUS OPERATIONS REPORT FOR THE
2013 MID-CAYMAN RISE CRUISE

WHOI Nereus Operations Group

Nereus Expedition Leader: Casey Machado

Chief Scientists: Dr. Christopher German (WHOI)

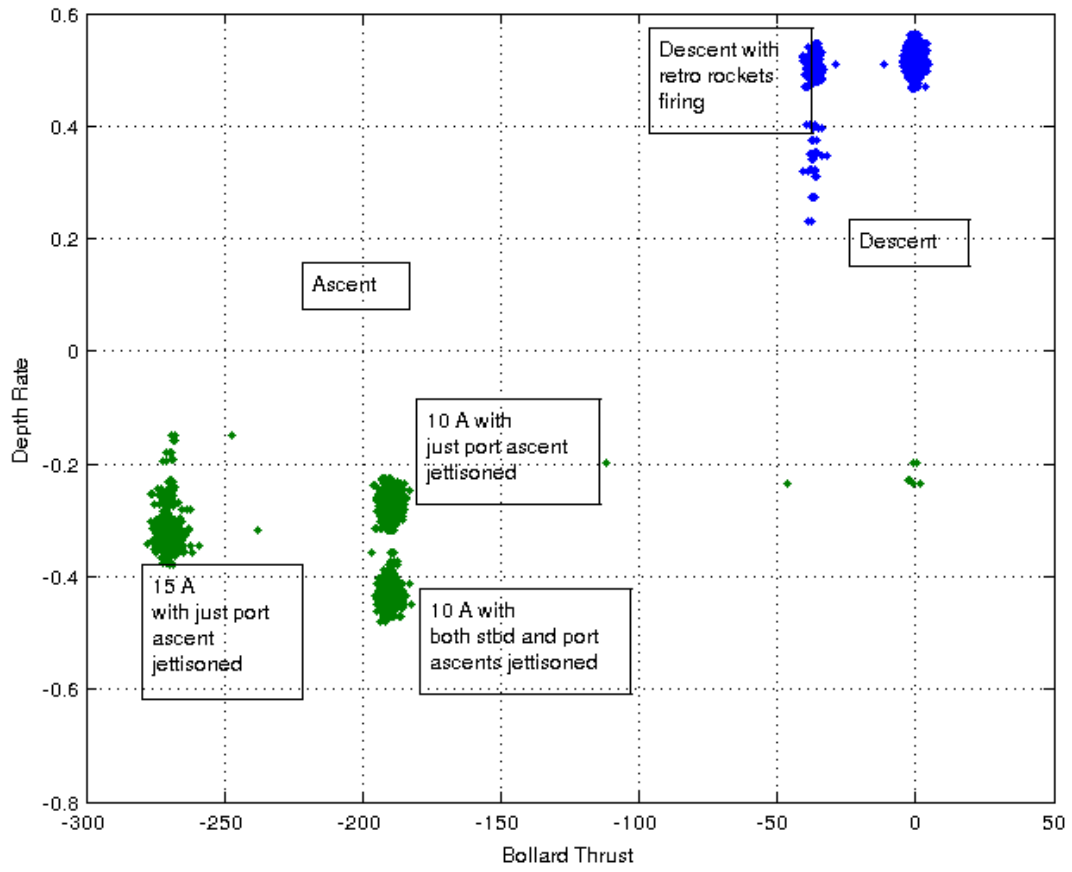
1. This dive ended on account of excessive negative buoyancy. Inspection of the vehicle data after recovery provided ample ballasting information. By comparing ascent and descent rates with the forward vertical thrusting at various current commands (Fig. 2) we concluded that the vehicle was indeed negative, by approximately 60 lb (based on flume data collected previously for this propeller). Ballasting for the following dive was corrected conservatively by removing 30 lb of lead.

Figure 2: Ballasting diagnosis for nereus047.

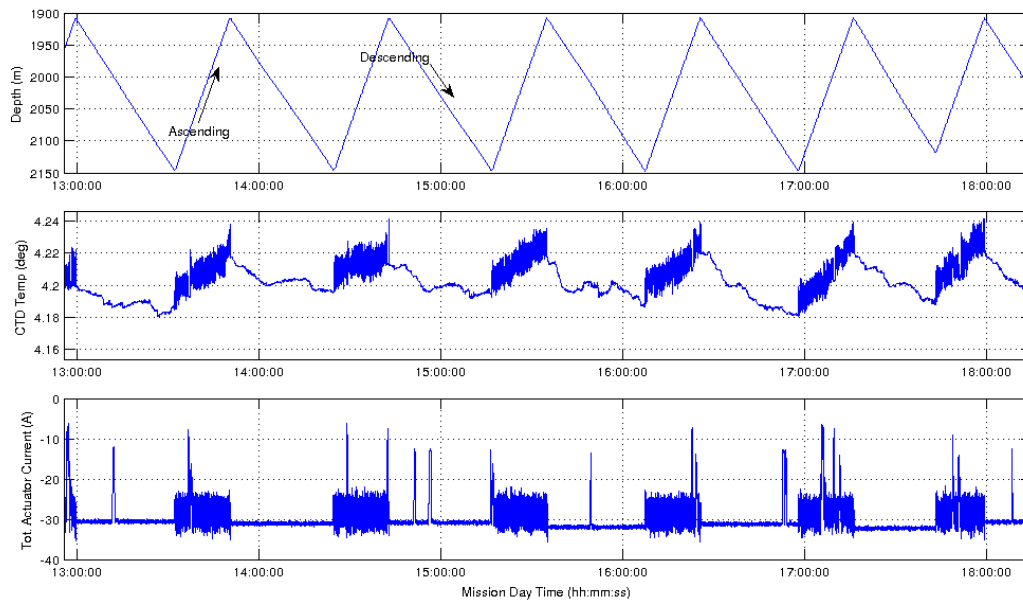
The on-board CTD data (temperature and derived products) are strongly correlated with the ascent vs. descent, with apparently much higher noise observed on the ascents. This appears to be due to electrical noise from the vehicle. During ascents the midplane and aft stabilizer were active and drawing variable current which appears to have bled into at least the temperature measurement of the CTD. During descents the midplane and aft stabilizers were saturated and drawing steady current. The thrusters were controlled open loop for the entire dive and drew constant current. Fig. 4 illustrates the effect. The implication is that cross-comparisons between the hydrographic data collected on ascending vs. descending legs may be compromised.

Figure 4: Correlation between ascending vs. descending yoyo legs, CTD noise (in situ temperature), and total current draw by all actuators.

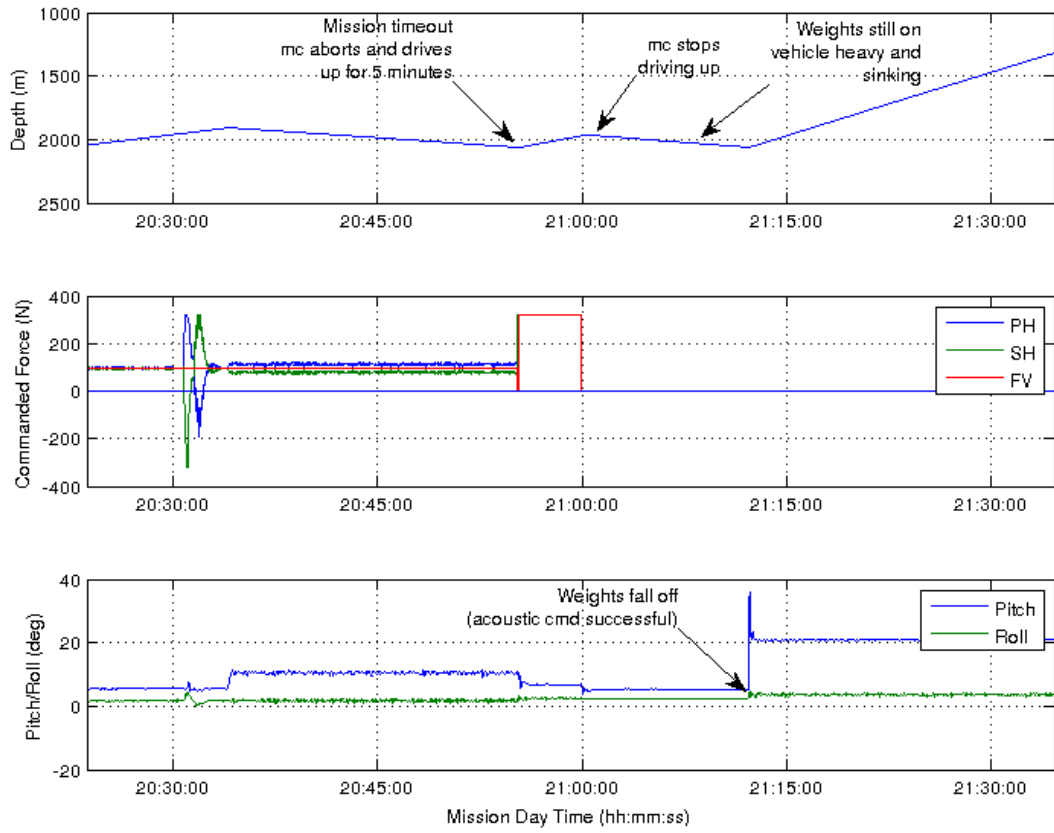
Upon mission timeout the vehicle initially ascended, then descended for a brief period before operators issued acoustic abort commands (Fig. 5). The vehicle was high in the water column and in no danger. The initial ascent was caused by the mission controller commanding full thrust up as is normal during both the abort and ascent mission. The mission controller's ascent and abort missions differ in a crucial way, however. The ascent mission drops weights, the abort mission does not (this difference was not apparent on earlier dives because the hardware deadman and mission timeout were almost coincident in time, or an acoustic abort was issued before mission timeout). The descent following the initial ascent was caused by negative buoyancy. Additional ballast weight had been added prior to this dive after misinterpreting differences in performance while ascending versus descending as ballast-related, rather than trim and drag-related.

Figure 5: Mission timeout and ascent behavior.
